LESSONS LEARNED FROM A SEGMENTAL RETAINING WALL FAILURE

James G. Collin

The Collin Group, Ltd., 11 Plantation Court, North Bethesda, MD 20852 301-881-7476

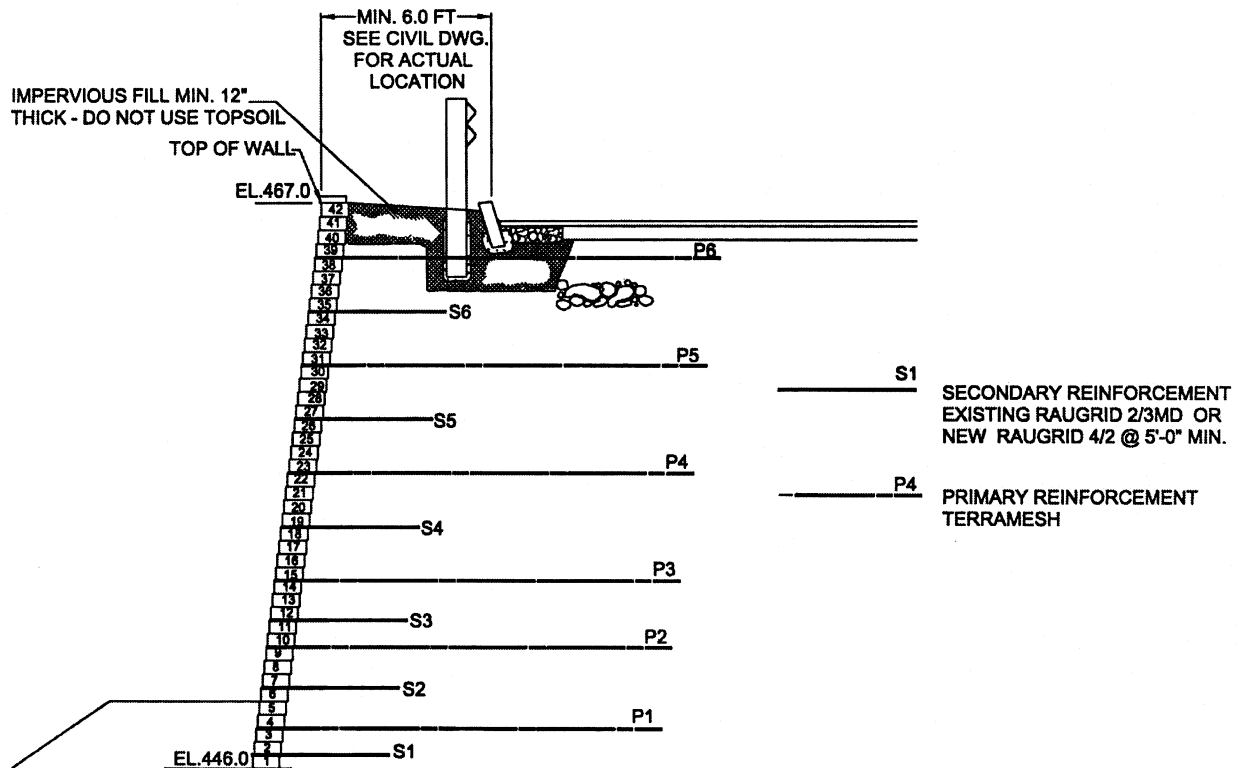
Figure 1. Typical SRW Design Cross Section

A typical cross-section of the wall consisted of primary reinforcement (steel mesh) placed 4 foot on center vertically. The steel mesh, because of its stiffness and thickness (over ¼ inch) was not attached directly to the SRW units. The steel mesh was brought to the back of the SRW units and was terminated before being connected to the SRW units. One layer of secondary reinforcement (PVC coated polyester geogrid) was placed at the mid-height of the primary reinforcement. The secondary reinforcement was attached to the SRW units and extended 3 feet into the reinforced soil mass behind the back of the SRW unit. A typical cross-section of the wall is shown in Figure 1.

Table 5 lists the factors of safety for facing stability of the wall and considers only the secondary reinforcement. Only the secondary reinforcement was considered because the primary reinforcement was not connected to the SRW units but was terminated behind the SRW unit. The design did not meet the recommended factor of safety for connections of 1.5 (per NCMA). In fact, the connection was substantially under-designed. The average factor of safety for the connection was approximately 0.50. The connection between the face of the wall and the reinforced soil mass was capable of carrying only 50% of the design load with no factor of safety. However, the wall did not fail until 6 months after it was complete and not until it was subjected to hydrostatic forces. A review of the original design would suggest that water was the trigger to the failures, but was not the cause of the failures. The cause of the failures was the low overall connection strength of the wall face to the reinforced soil mass through the secondary reinforcement.

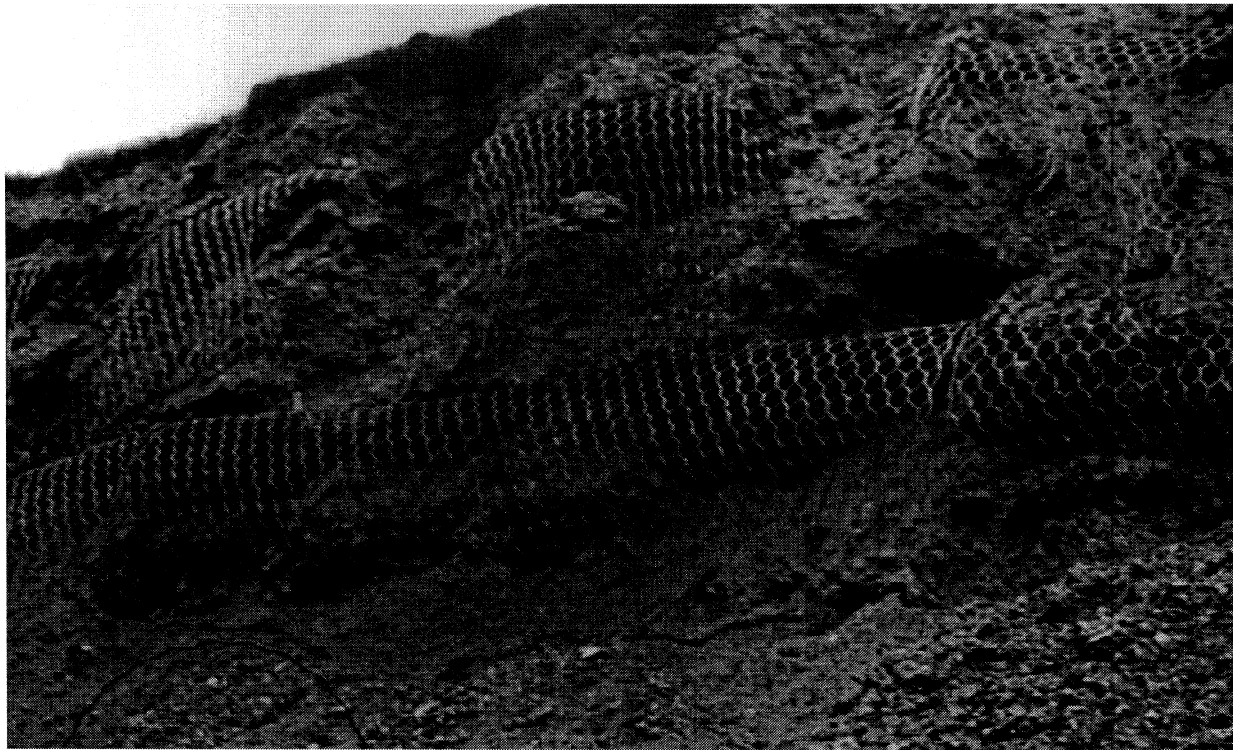
The first failure occurred at the end of May 1999. The highest section of wall (28.5 ft) failed during a heavy rain storm. Water drained to a catch basin located behind the wall. At the time of the failure, the parking lot above the wall had not been paved, leaving the catch basin entrance above existing ground. Thus, the site water directed to that area could not enter the catch basin and drained into the reinforced fill, subsequently saturating it. Photograph 1 shows the wall after failure. The face of the wall (SRW units and secondary reinforcement) peeled away from the reinforced soil mass. It is evident from the photograph that the reinforced soil mass supported by the primary reinforcement was still performing. The failure was confined to the wall face.

A second failure occurred in September of 1999 during Hurricane Floyd. This failure appeared similar to the first, in that the SRW units, secondary reinforcement and reinforced fill within about 3 to 4 feet behind the face of the wall fell away from the soil mass reinforced by the primary reinforcement.

Both failures occurred during or shortly after significant rainfall events. Water appeared to be the trigger for both failures. Observations the day after the second failure revealed no evidence of seepage, erosion or water movement at the reinforced soil face. The near vertical face

appeared to consist of uniformly damp, relatively undisturbed glacial till backfill. During a heavy rain a few days after the failure water was observed flowing out of the pavement base course at the collapsed section of wall.

Photograph 1. Wall Failure - Primary Reinforcement Visible

It appears that for the second failure, the primary water source is near surface infiltration laterally from the adjacent pavement base course and vertically through the grass area between the pavement and the wall face.

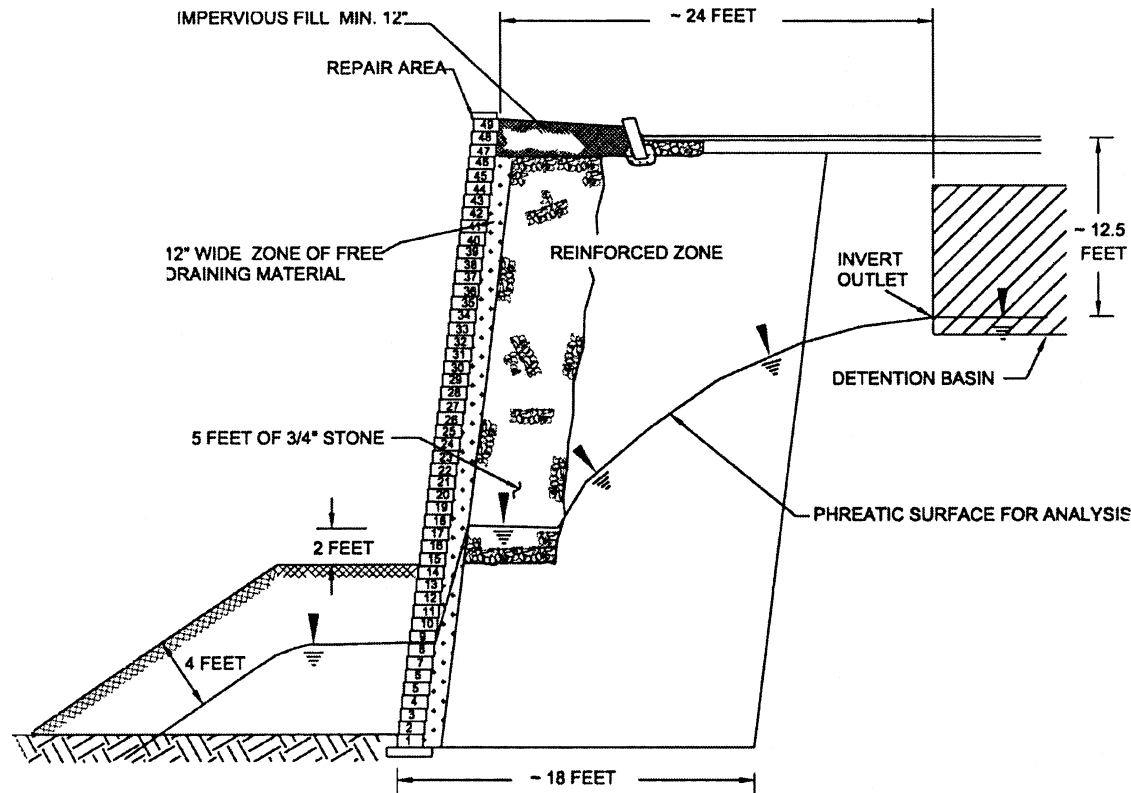
Figure 2. Remedial Design – Location of Phreatic Surface

Both wall failures occurred during heavy rain storms. It was obvious that the remedial designs must consider the impact of water on the stability of the structure. As part of the failure analysis the original civil drawings were reviewed. These drawings revealed that a storm water detention structure was located below the parking lot within 25 feet of the face of the SRW. The potential impact of water from this structure loading the reinforced soil mass was therefore included in the design for the fix for the wall. Figure 2 shows the phreatic surface that was used in the redesign of the wall.

Current SRW design software does not allow for the modeling of hydrostatic pressures within the reinforced soil mass. Therefore, a spread sheet was developed to analyze the stability of the SRW for external, internal, and facing stability considering hydrostatic forces. The remedial design was developed to meet industry standards for external, internal, facing and global stability considering hydrostatic forces.
