Field observations of reinforced soil structures under seismic loading

ABSTRACT: Design considerations for the stability of reinforced soil structures when subjected to seismic loadings is briefly reviewed. Because of the flexible nature of these structures, they are generally believed to perform well when subjected to horizontal ground accelerations. The performance of five reinforced slopes and walls that experienced the Loma Prieta earthquake of 1989 are evaluated. The observed performance of these structures demonstrates the ability of reinforced soil to withstand large ground motions.

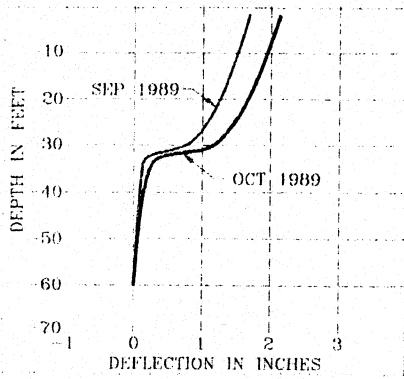
Figure 6. La Honda
Inclinometer Data

The inclinometer data clearly shows movement of the upper (steeper) portion of the slope after the earthquake (Figure 6). This movement is less than 2 cm, which is approximately 0.2% of the slope height.
